**Flood Control Project Maintenance
Levee Inspections**

Spring 2012 Levee Inspection Results

Sacramento River West Side Levee District

Levee Inspection Report By Mile - Spring 2012

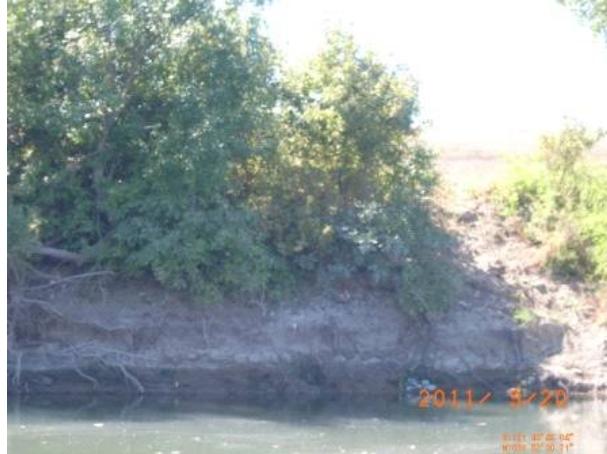
USACE 2011 Photo #2

Levee Mile Report Line	14
Start Levee Mile	10.03
End Levee Mile	11.51
Location	Water Side
Category	Supplemental
Item	USACE Erosion Survey

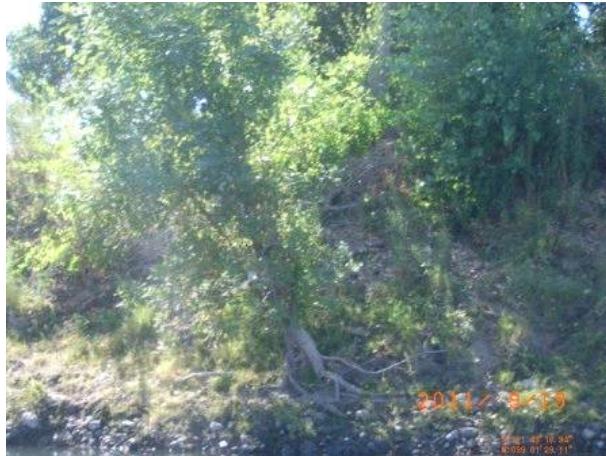
USACE 2011 Photo #1

Levee Mile Report Line	29
Start Levee Mile	23.69
End Levee Mile	23.69
Location	Water Side
Category	Supplemental
Item	USACE Erosion Survey

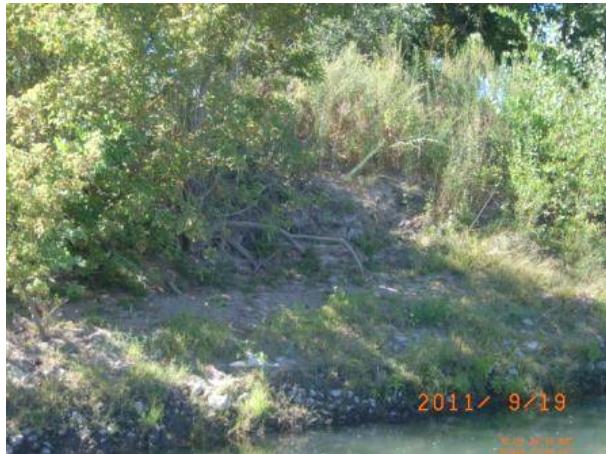
USACE 2011 Photo #2

Levee Mile Report Line	29
Start Levee Mile	23.69
End Levee Mile	23.69
Location	Water Side
Category	Supplemental
Item	USACE Erosion Survey

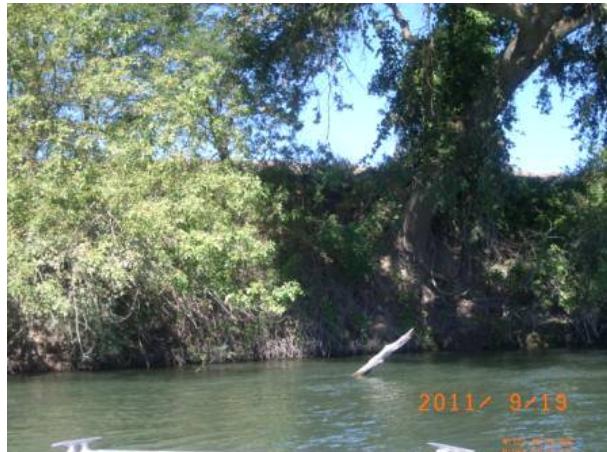
USACE 2011 Photo #2

Levee Mile Report Line	31
Start Levee Mile	25.91
End Levee Mile	25.91
Location	Water Side
Category	Supplemental
Item	USACE Erosion Survey

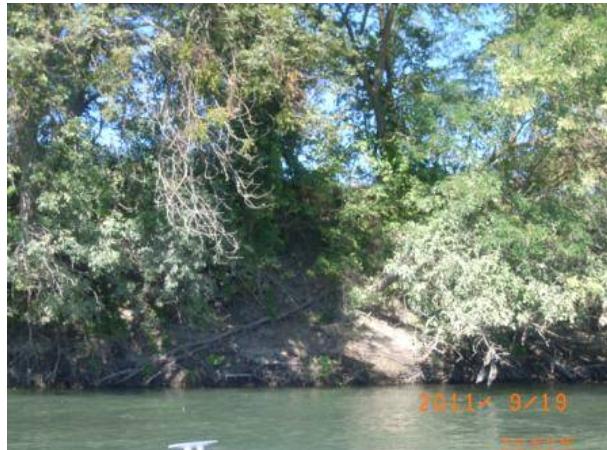
USACE 2011 Photo #3

Levee Mile Report Line	31
Start Levee Mile	25.91
End Levee Mile	25.91
Location	Water Side
Category	Supplemental
Item	USACE Erosion Survey

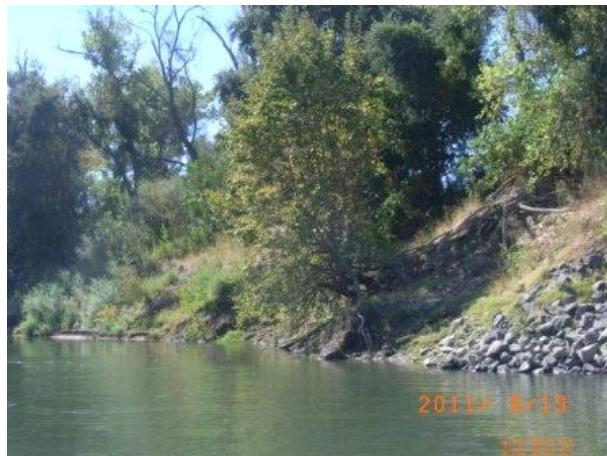
Levee Mile Report Line	34
Start Levee Mile	29.98
End Levee Mile	29.98
Location	Water Side
Category	Supplemental
Item	USACE Erosion Survey
USACE 2011 Photo #1	
johngw_s_20120313_186.jpg

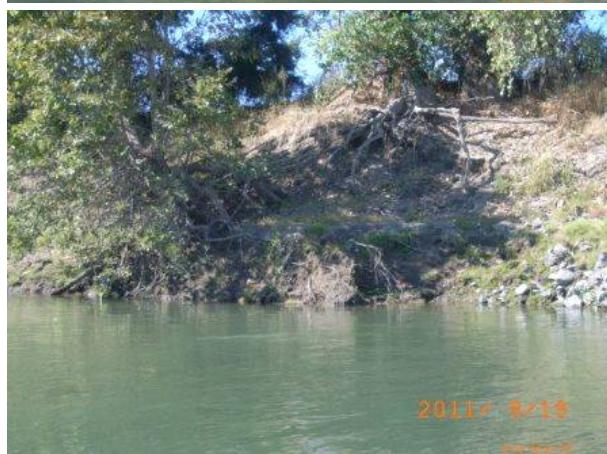
Levee Mile Report Line	34
Start Levee Mile	29.98
End Levee Mile	29.98
Location	Water Side
Category	Supplemental
Item	USACE Erosion Survey
USACE 2011 Photo #2	
johngw_s_20120313_187.jpg

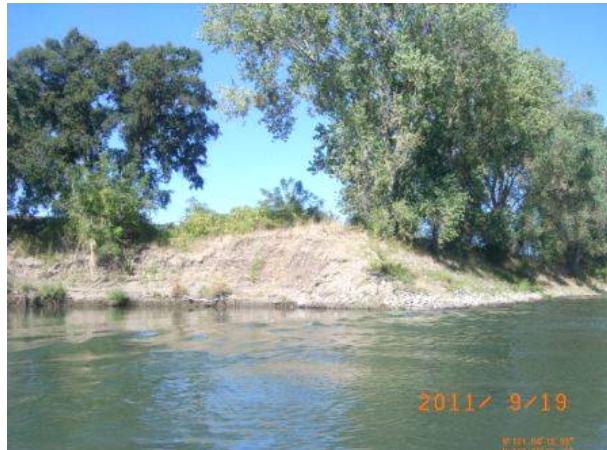
USACE 2011 Photo #2

Levee Mile Report Line	44
Start Levee Mile	35.62
End Levee Mile	35.62
Location	Water Side
Category	Supplemental
Item	USACE Erosion Survey

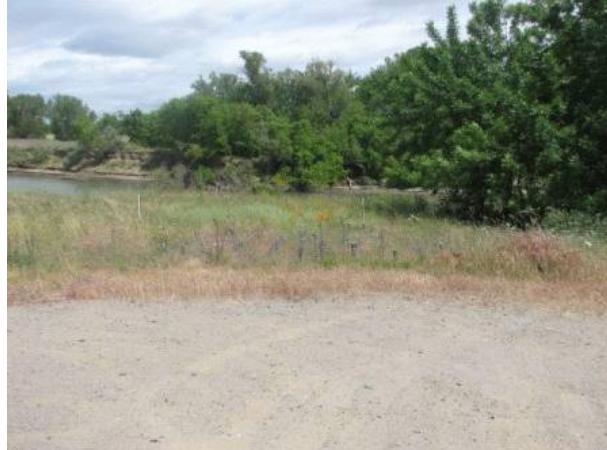
The revegetation on the berm with the fence and stakes.

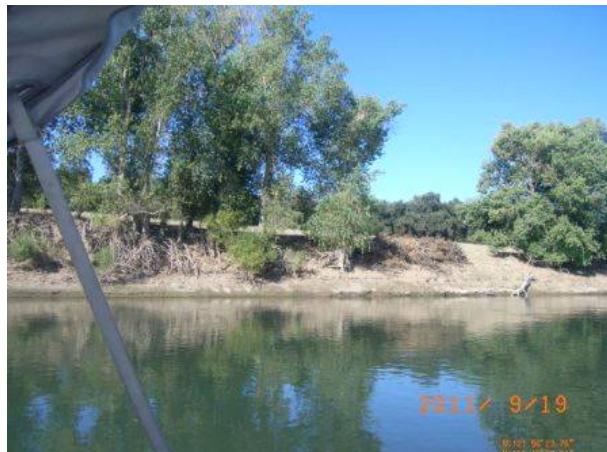
USACE 2011 Photo #1

Levee Mile Report Line	47
Start Levee Mile	43.35
End Levee Mile	43.35
Location	Water Side
Category	Supplemental
Item	USACE Erosion Survey

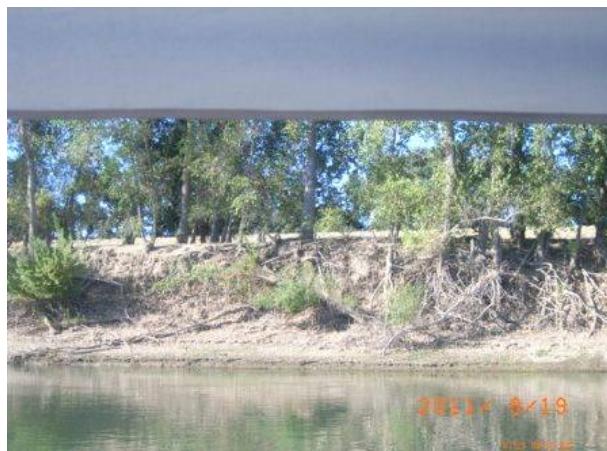
USACE 2011 Photo #2

Levee Mile Report Line	47
Start Levee Mile	43.35
End Levee Mile	43.35
Location	Water Side
Category	Supplemental
Item	USACE Erosion Survey

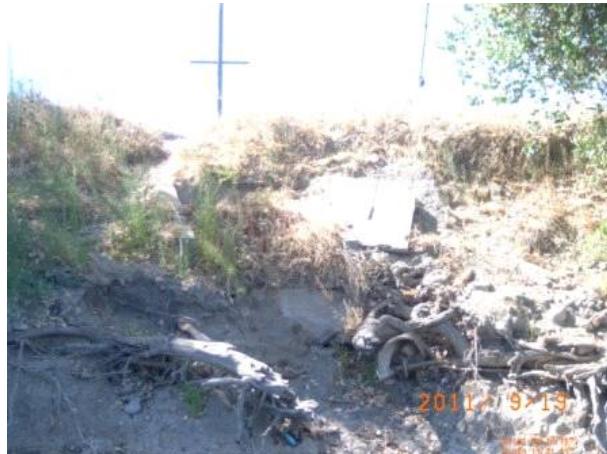
USACE 2011 Photo #2

Levee Mile Report Line	54
Start Levee Mile	48.11
End Levee Mile	48.11
Location	Water Side
Category	Supplemental
Item	USACE Erosion Survey
